**Table 13-2.** Minor diversions on the EMI System in the Waiokamilo hydrologic unit.

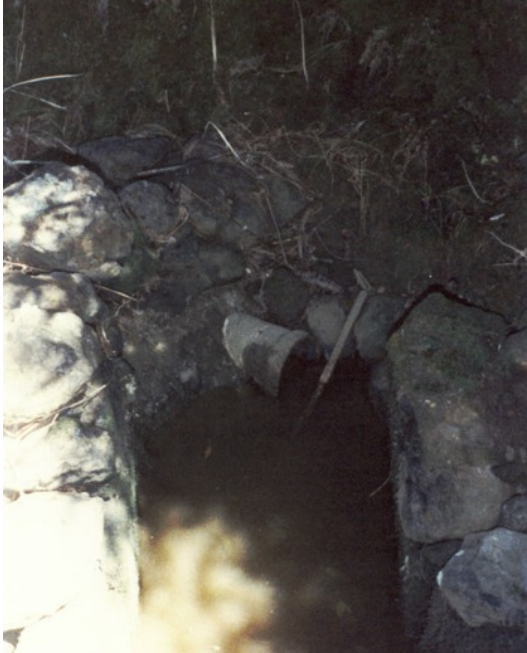
Diversion ID	EMI Ditch System	Description
K-22a	Koolau	6-inch Kulani aluminum pipe intake diverted to main Kulani intake. Concrete catchment basin with pipe.

**Photos.** a) Concrete catchment basin captures seepage and transports water to Koolau Ditch below via an aluminum pipe (EMI, 05/1989); b) Upstream view from below basin with PVC pipe at bottom center of photo (RMT, 12/2007); c) PVC pipe disconnected (RMT, 12/2007).
