**Table 13-2.** Continued. Minor diversions on the EMI System in the Waiokamilo hydrologic unit.

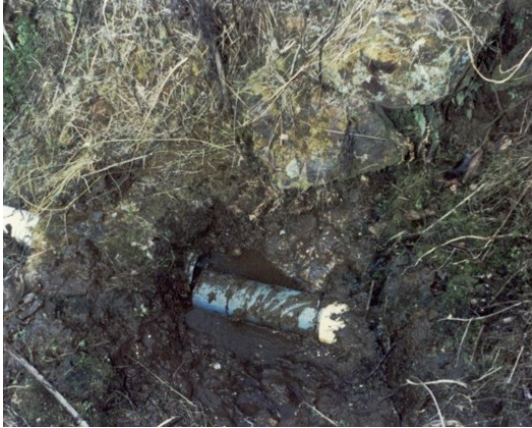
Diversion ID	EMI Ditch System	Description
K-22c	Koolau	Koolau Ditch #10 crosscut intake #2. Concrete catchment basin with pipe.
<b>Photos.</b> a) Concrete catchment basin captures seepage and transports water to Koolau Ditch below via a PVC pipe (EMI, 05/1989); b) Upstream view from below capture of seepage with PVC pipe disconnected (RMT, 12/2007).		
a)

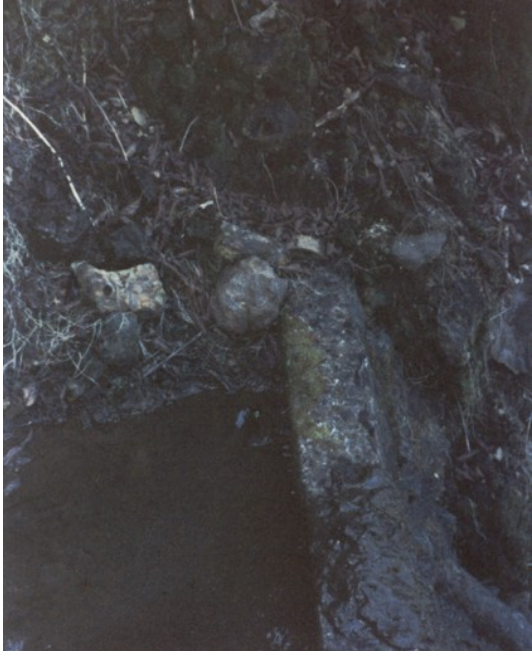
K-22d	Koolau	Koolau Ditch #10 crosscut intake #3. Concrete catchment basin with pipe.
<b>Photos.</b> a) Concrete catchment basin captures seepage and transports water to Koolau Ditch below via a pipe (EMI, 05/1989); b) Close-up of disconnected pipe below basin (RMT, 12/2007).		
a)
