Table 13-2. Continued. Minor diversions on the EMI System in the Waiokamilo hydrologic unit.

Diversion ID	EMI Ditch System	Description
K-25a	Koolau	East Kikokiko 2-inch pipe intake. Concrete catchment basin with pipe.

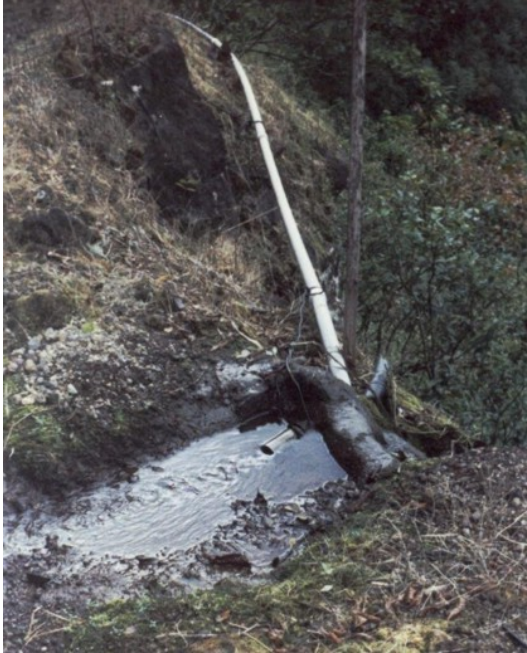
Photos. a) Concrete catchment basin captures seepage and transports water to Koolau Ditch below via a PVC pipe (EMI, 05/1989); b) Downstream view from diversion structure (RMT, 12/2007); c) Water dropping into concrete catchment basin below roadway (RMT, 12/2007).
