Table 13-2. Continued. Minor diversions on the EMI System in the Waiokamilo hydrologic unit.

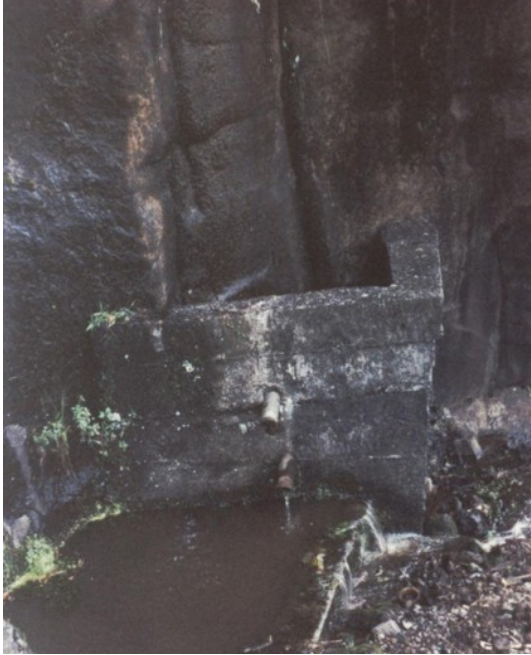
Diversion ID	EMI Ditch System	Description
K-25e	Koolau	West Kikokiko 3-inch pipe intake. Concrete catchment basin with pipe.
Photos. a) Concrete catchment basin captures seepage and transports water to Koolau Ditch below via a PVC pipe (EMI, 05/1989); b) Water flowing downstream below catchment basin from disconnected PVC pipes (RMT, 12/2007).		
a)
