Table 13-1. Registered diversions in the Waiokamilo hydrologic unit.

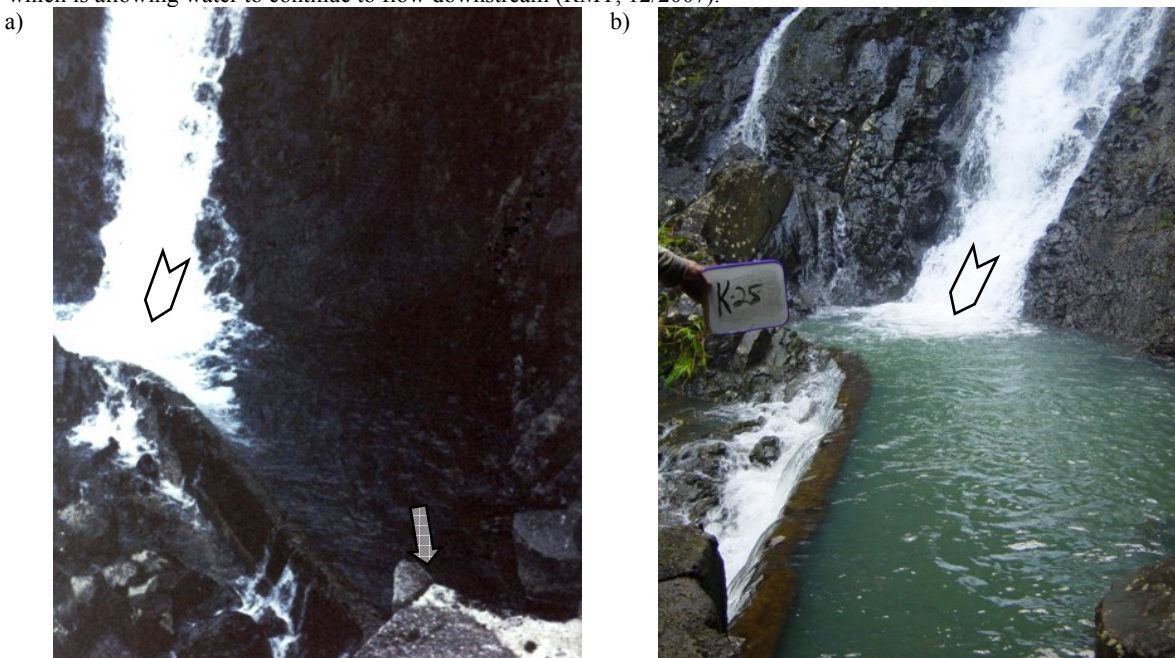
Photos. a) The diversion intake structure captures water at the foot of the falls and directs it into the intake at bottom right (EMI, 05/1989); b) Photo is taken after intake was supposedly cemented shut in response to the Land Board's interim order, which is allowing water to continue to flow downstream (RMT, 12/2007).
