**Table 13-2.** Continued. Minor diversions on the EMI System in the Waiokamilo hydrologic unit.

Diversion ID	EMI Ditch System	Description
K-22e	Koolau	Koolau Ditch #10 crosscut intake #4. Concrete catchment basin with pipe.

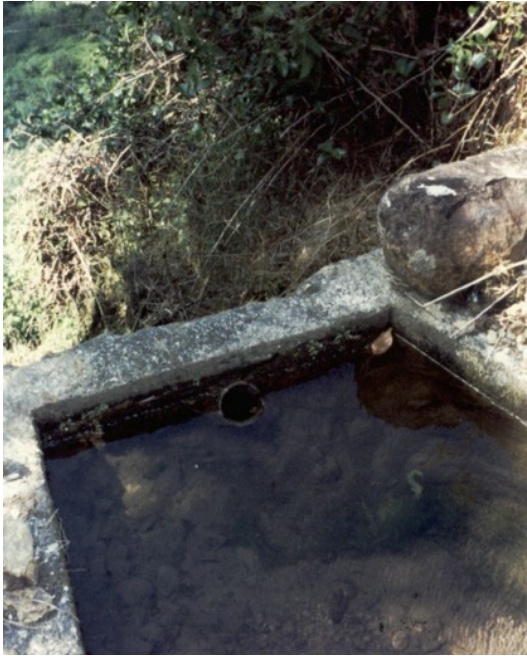
**Photos.** a) Concrete catchment basin captures seepage and transports water to Koolau Ditch below via a PVC pipe (EMI, 05/1989); b) Close-up view of PVC pipe outlet from catchment basin (RMT, 12/2007); c) According to EMI, the pipe intake in the catchment basin was capped, allowing water to overflow basin and flow downstream as depicted in photo (RMT, 12/2007).
