Table 13-2. Continued. Minor diversions on the EMI System in the Waiokamilo hydrologic unit.

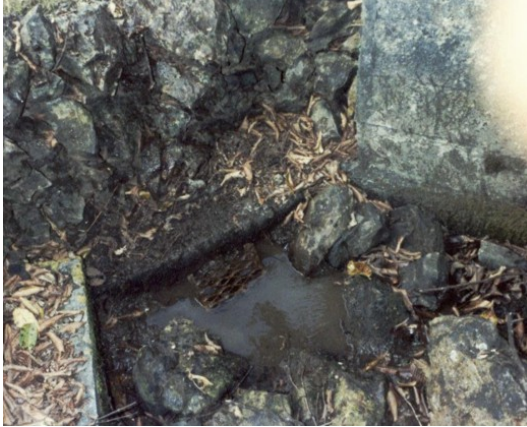
Photos. a) Concrete catchment basin captures seepage and transports water to Koolau Ditch below via a PVC pipe (EMI, 05/1989); b) Upstream view from below capture of seepage with PVC pipe at top center of photo (RMT, 12/2007); c) Close-up of capped PVC pipe (RMT, 12/2007).
